REPAIRING OF GIRTH GEAR CRACKS

CUSTOMER'S FIRST RECALL IN-SITU SOLUTION FOR GIRTH GEAR CRACKS

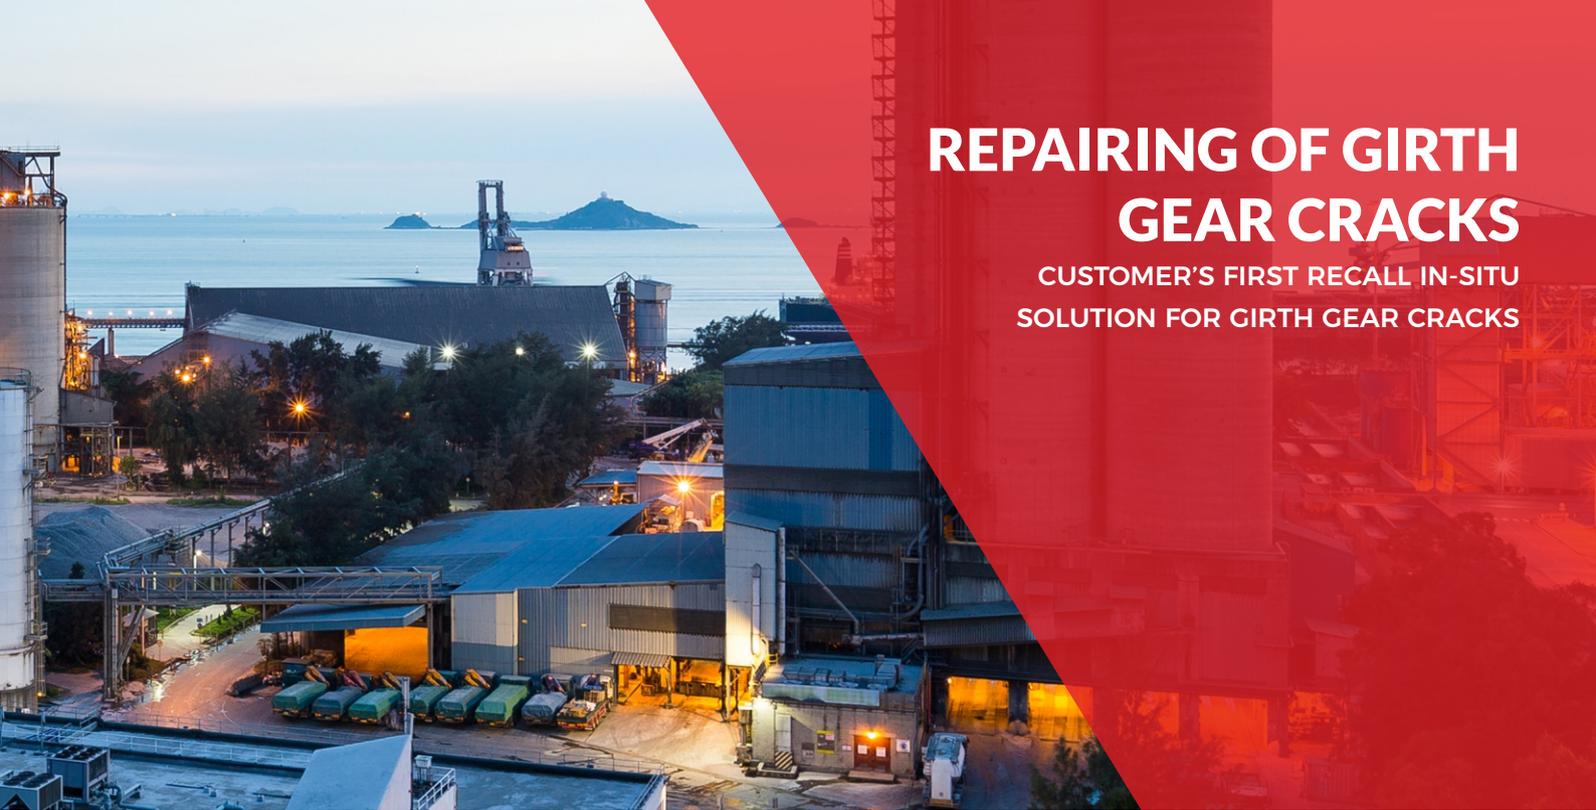
Cracks are normally observed on gear tooth of kiln girth gear, cement mill and raw mill girth gear due to ageing, wear & tear or due to heavy jerking sometime leading to tooth breakage. Girth gears are not readily available in stock and are generally made to order with a lead time of 6 months to 1 year, thereby leading to downtime loss resulting in production loss with high cost of replacement. Hence, reclamation is an ideal solution.

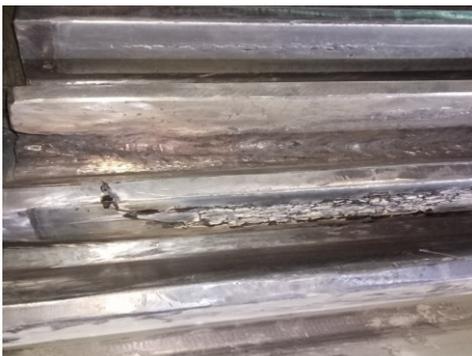
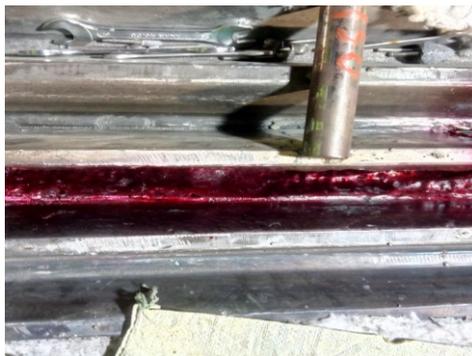
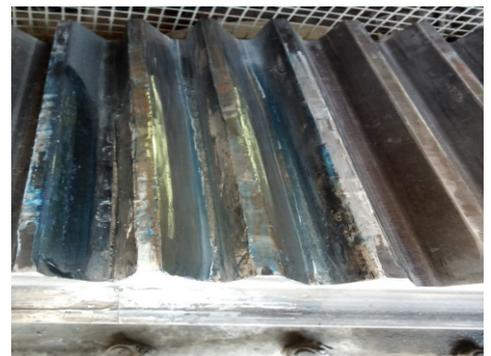
Job needs to be done in-situ; Crack is tested with NDT (Non Destructive Testing) to ensure no further propagation. Grooves must be prepared to the depth of the crack. A buttering layer with our specialised electrode, LH-1105 ensures purging of all internal impurities. Welding is then completed with our unique product for breakdown LH-521,

thereby providing maximum safety margin for this application. Welded components are then finished to the required profile by grinding.
