COARSE FEED VALVES/ ROTARY AIR-LOCKS

TOTAL REFURBISHMENT OR NEW
MANUFACTURE

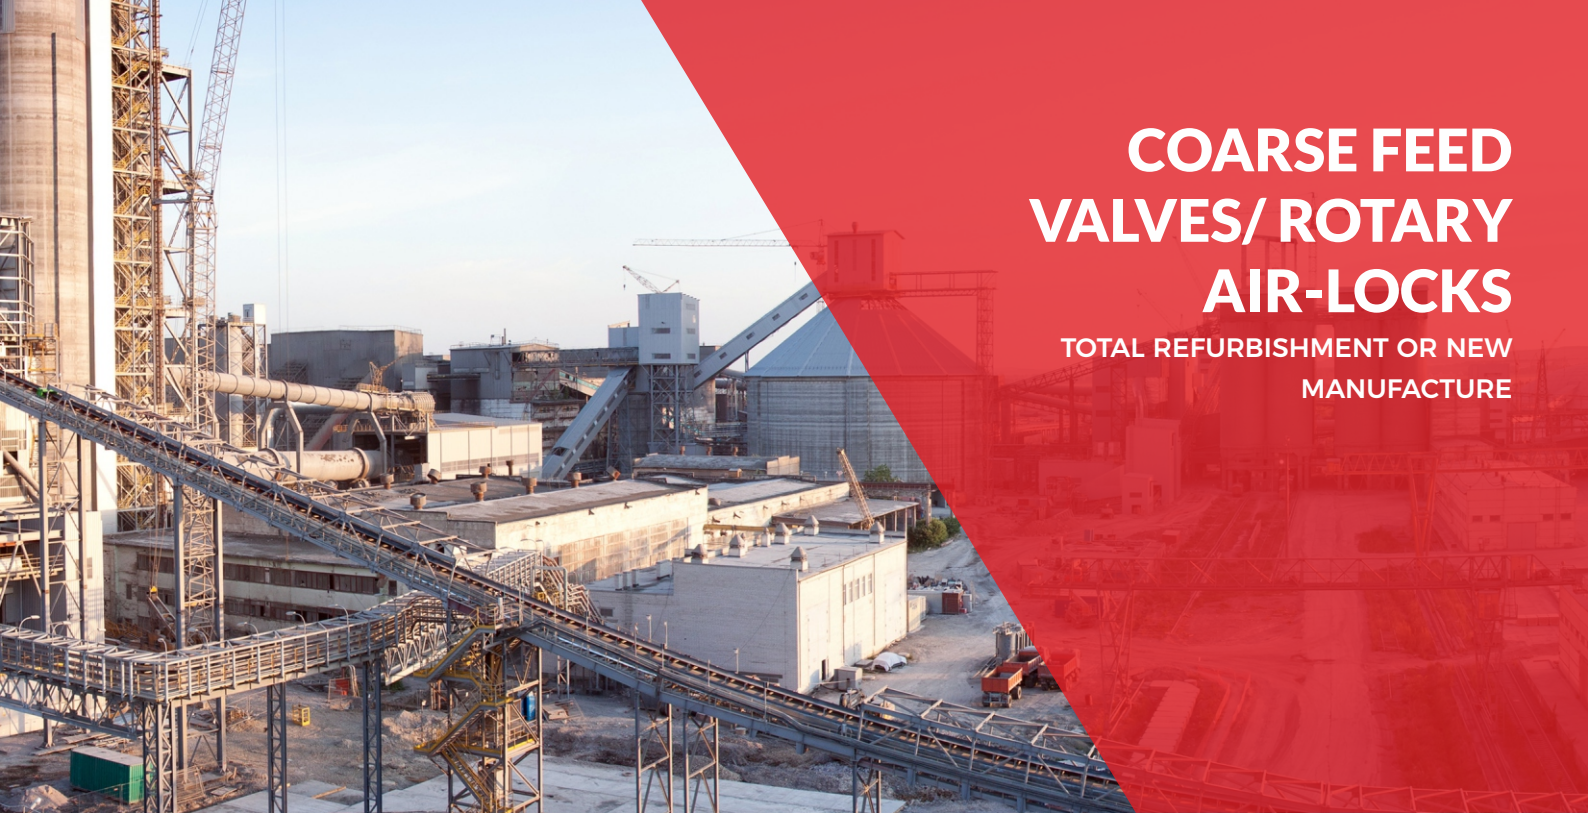
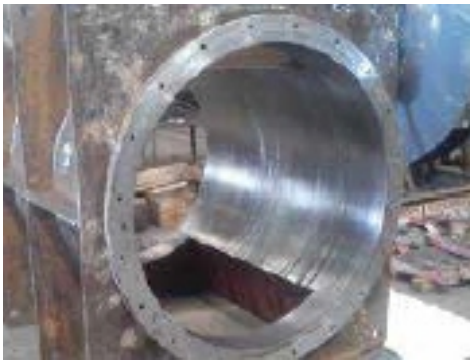
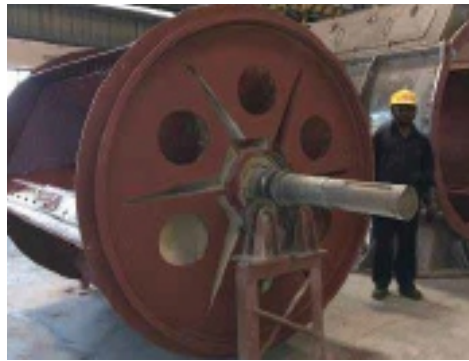
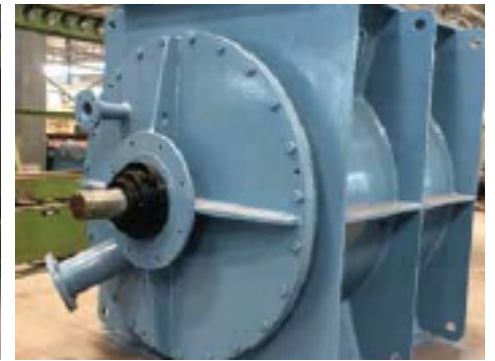
The body & rotor wears due to heavy grinding abrasion. The gap between rotor blades and body increases making it difficult to control feed rate and smooth operation of rotor.

Refurbish the body and rotor with added features like use of 'Hardox' or 'Enduraplates' or 'Cast-fused' liners for enhanced resistance to severe abrasion. The performance life is enhanced considerably.

- Removal of worn-out parts
- Fabrication of new parts
- Machining of rotor & body
- Fitting of new liners & assembly
- Balancing & finishing
