# ROLLER PRESS - BEARING HOUSINGS

TOTAL REFURBISHMENT OF ID  
I.E. BEARING SEAT

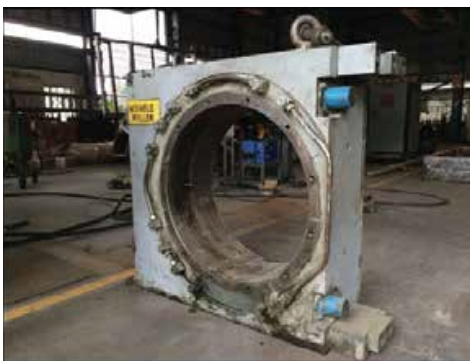
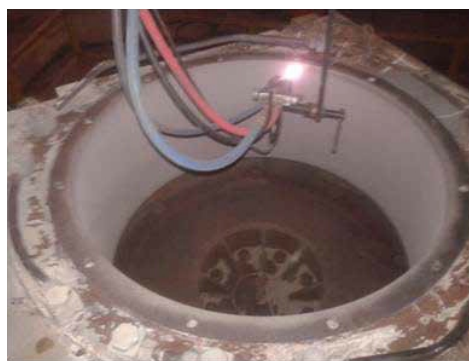
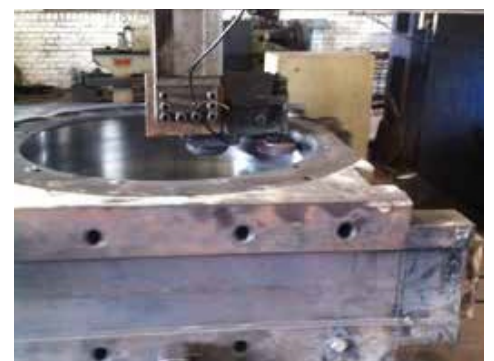
The ID of the bearing housing wears out due to relative motion between bearing and housing. This results in free rotation of bearing and may cause loss of lakhs of rupees due to seizure or breakage of bearing. The cost of bearing, cost of bearing change and loss of productivity are main concern.

Refurbish the body at ID and carry out machining.

- Undercut
- Build-up of worn out surface
- NDT of roller & shaft
- Repair of cracks if any
- Stress relieving
- Finished machining
- Inspection
